**AVIATION INVESTIGATION REPORT**  
**A0000057**

**MIDAIR COLLISION**

**BETWEEN**  
**ISLAND AIR FLIGHT SCHOOL & CHARTERS INC.**  
**CESSNA 172 C-GSAR**  
**AND**  
**CESSNA 337 SKYMASTER C-GZYO**  
**TORONTO/CITY CENTRE AIRPORT 18 NM NE**  
**13 MARCH 2000**

Report Number A00O0057

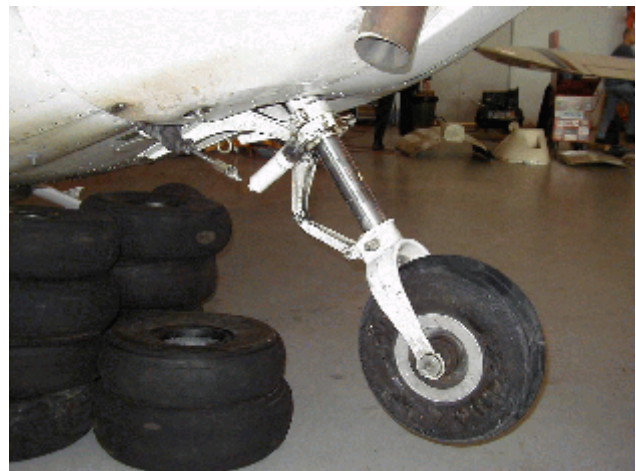
Records indicate that the Cessna 172 was certified, equipped, and maintained in accordance with existing regulations and approved procedures. It sustained substantial damage to the nose gear assembly and surrounding structure. The lower landing gear support/attach bracket was sheered off but remained attached to the landing gear leg. The upper landing gear support/attach bracket remained attached by one bolt. The steering arms were torn off at their attach points, the rudder torque tubes were bent, the lower firewall was wrinkled, the lower engine cowl mount was damaged and wrinkled, and the upper forward cockpit floor skin was slightly deformed.

**Figure 1** The damaged Cessna 172 nose gear assembly

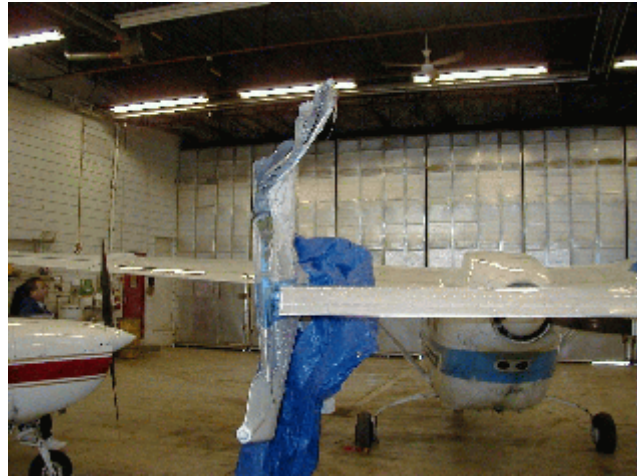
Records indicate that the Cessna 337 was also certified, equipped, and maintained in accordance with existing regulations and approved procedures. It sustained substantial damage to the left vertical tail and rudder. The aft portion of the upper half of the vertical tail was torn off along with the upper half of the rudder. The forward portion of the upper half of the vertical tail was bent inwards and displayed an imprint of the Cessna 172 nosewheel tire. The lower portion of the vertical tail and rudder were slightly deformed.

**Figure 2** The Cessna 337's left vertical tail and rudder

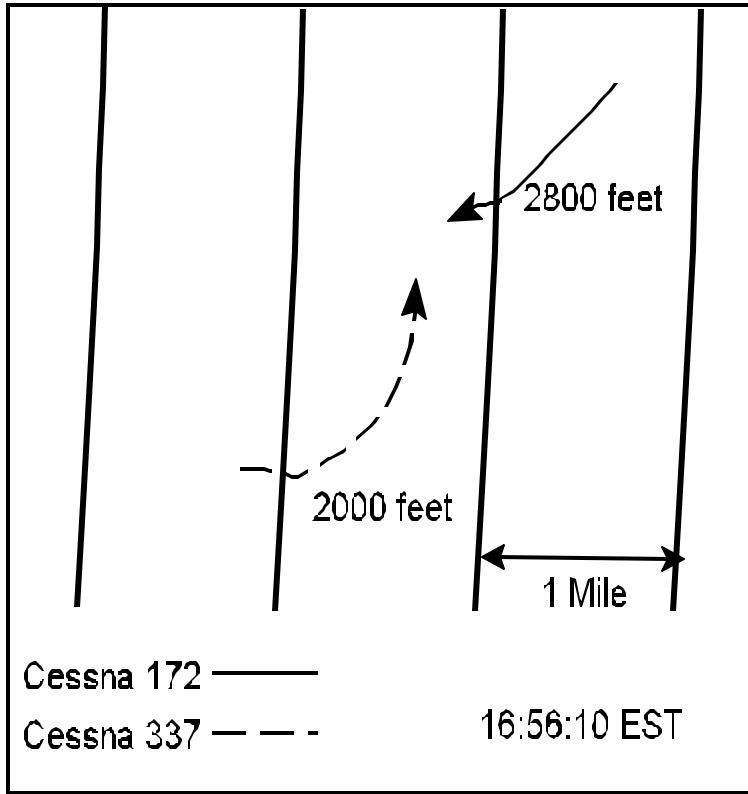
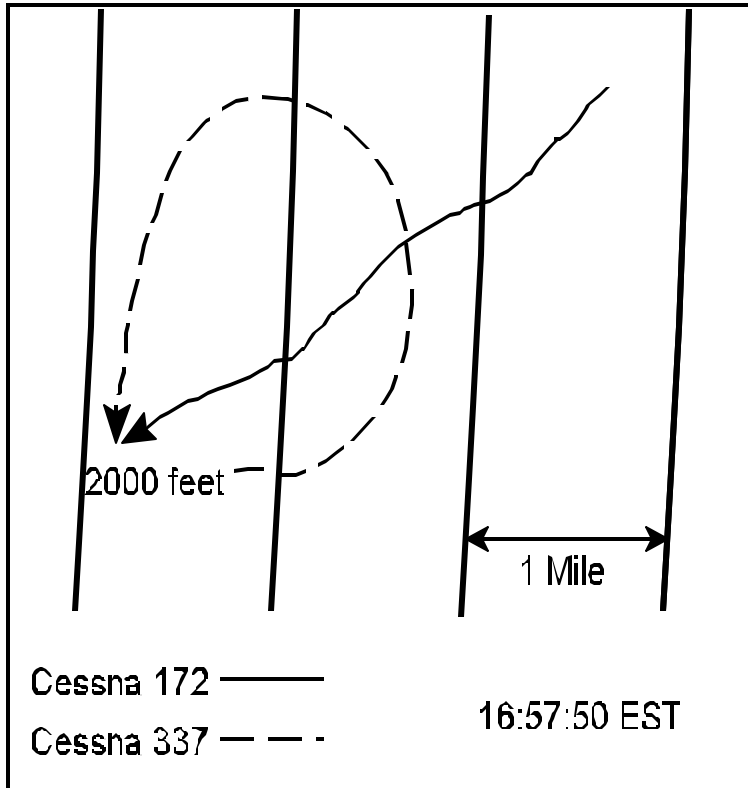
# Appendix A—Radar Depiction of Flights

At the time of the collision, the Cessna 172 was in a shallow descent with the wings level; while the Cessna 337 was in a gentle left turn with approximately 10 degrees of bank (see Appendix A). The Cessna 337 passed underneath the Cessna 172. The nosewheel of the Cessna 172 contacted the left vertical stabilizer of the twin-tailed Cessna 337. The instructor pilot of the Cessna 172 saw the Cessna 337 a split second prior to the collision, but the Cessna 337 pilot did not see the other aircraft until after the collision.
